Memorandum

Date: September 11, 2017

*Subject: Summary of Oversight of Cap Inspection at River Mile 10.9
August 21–22, 2017
Lower Passaic River Restoration Project*

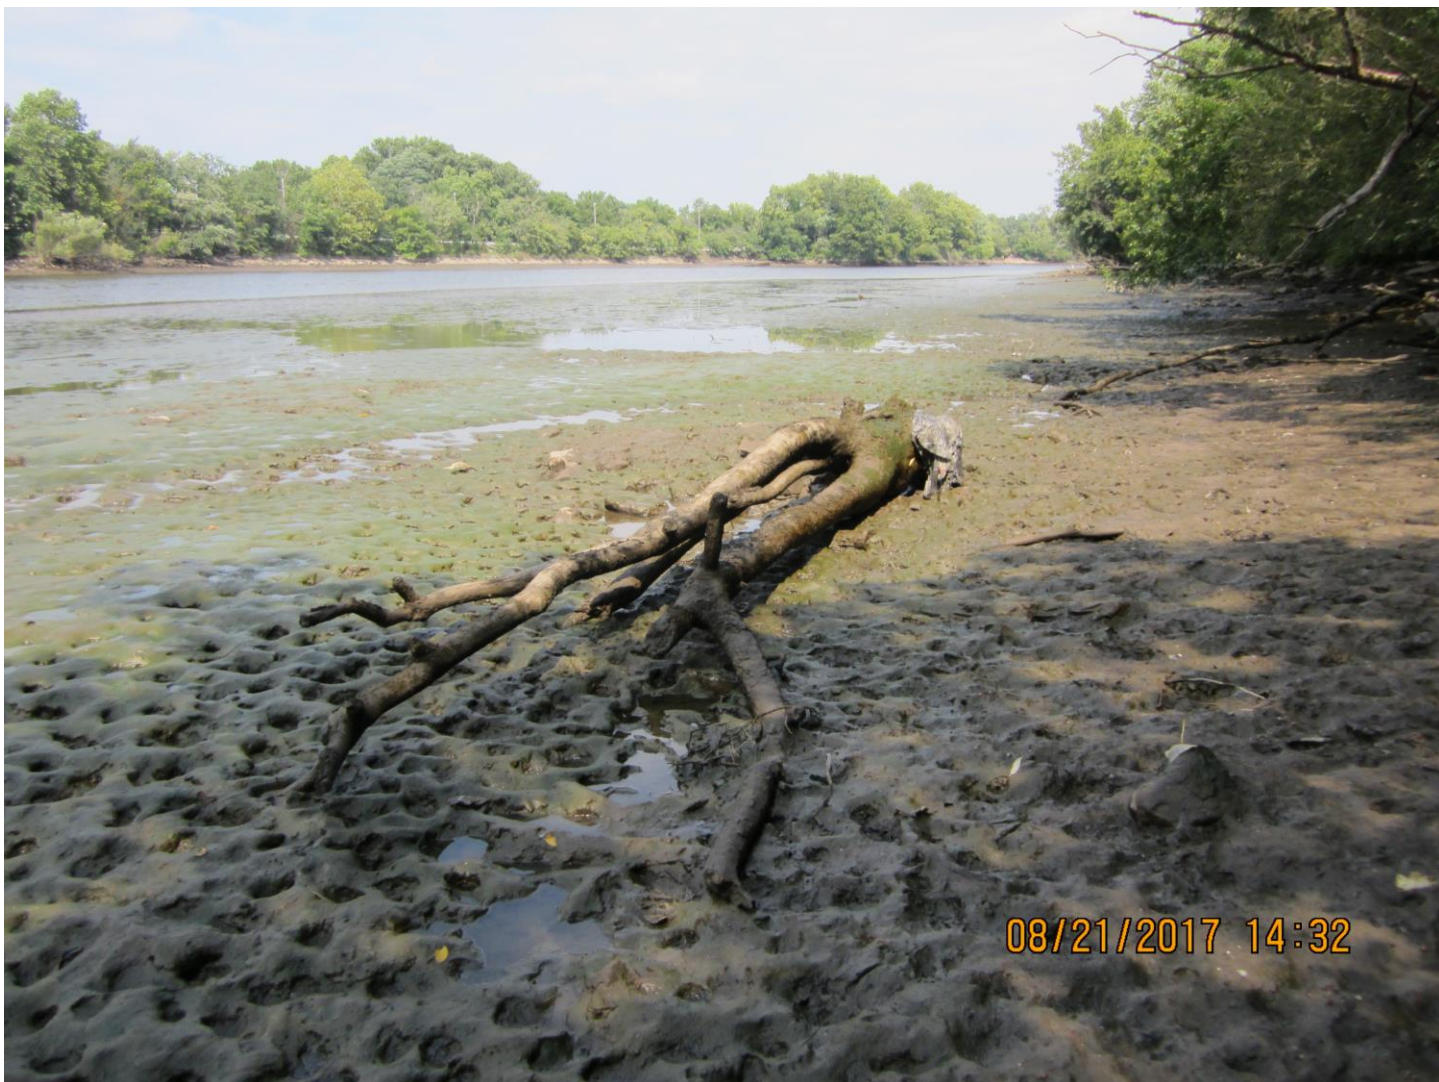
Large fallen branches were noted lying on sediment in the vicinity of Transect E but did not appear to puncture the cap (See Photograph 1).

Photograph 1: Fallen branches in vicinity of Transect E

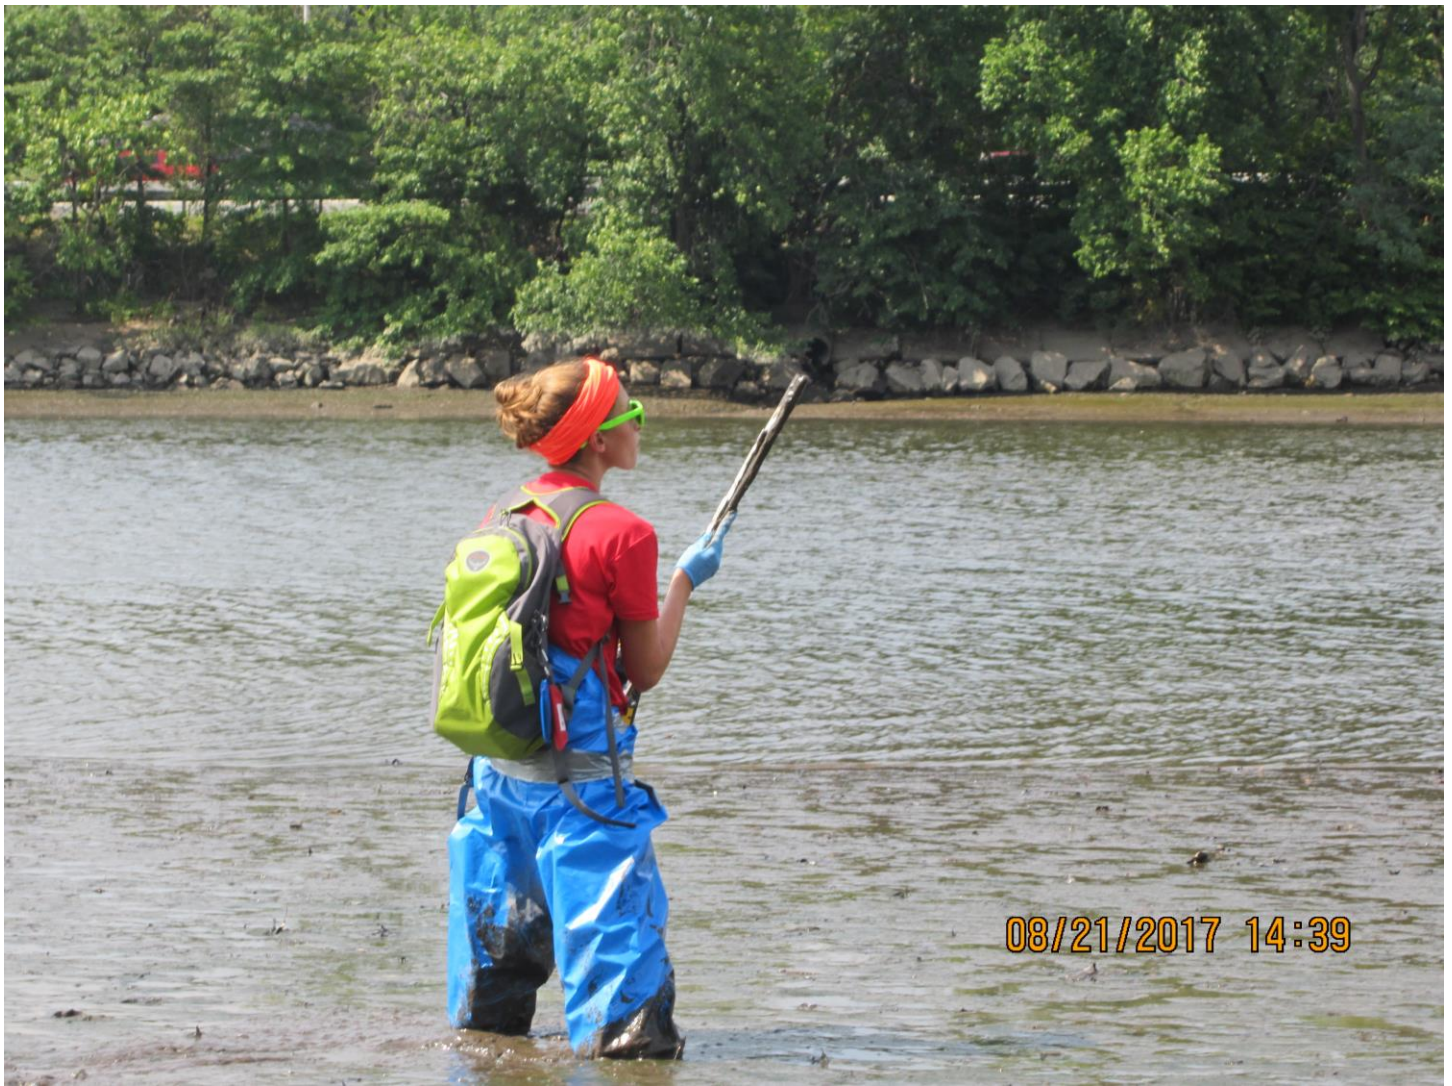
At two locations (E-3 and G-1), significant variations in depth to armor layer were observed. As a result, 36 locations were further probed along a 3 ft by 3 ft grid (with 6 inches between each measurement) at both E-3 and G-1. The locations within the first grid were labeled "AG-1" through "AG-36" and were centered around E-3 (close to the 0605 sampler station along Transect E). The locations within the second grid were labeled "BG-1" through "BG-36" and were centered around G-1 (close to the 0607 sampler station along Transect G). The depth measurements from the grids AG and BG are presented in Tables 2 and 3, respectively, below. The GPS coordinates of each individual point within the grids were not recorded due to lack of necessary GPS precision for the grid points, but the general GPS location of each grid was recorded. Diagram 1 provides a conceptual schematic of the grid AG layout (grid BG was laid out similarly).

Photograph 2: Measuring depth to armor layer at E-3 near 0605 sampling station (Transect E)

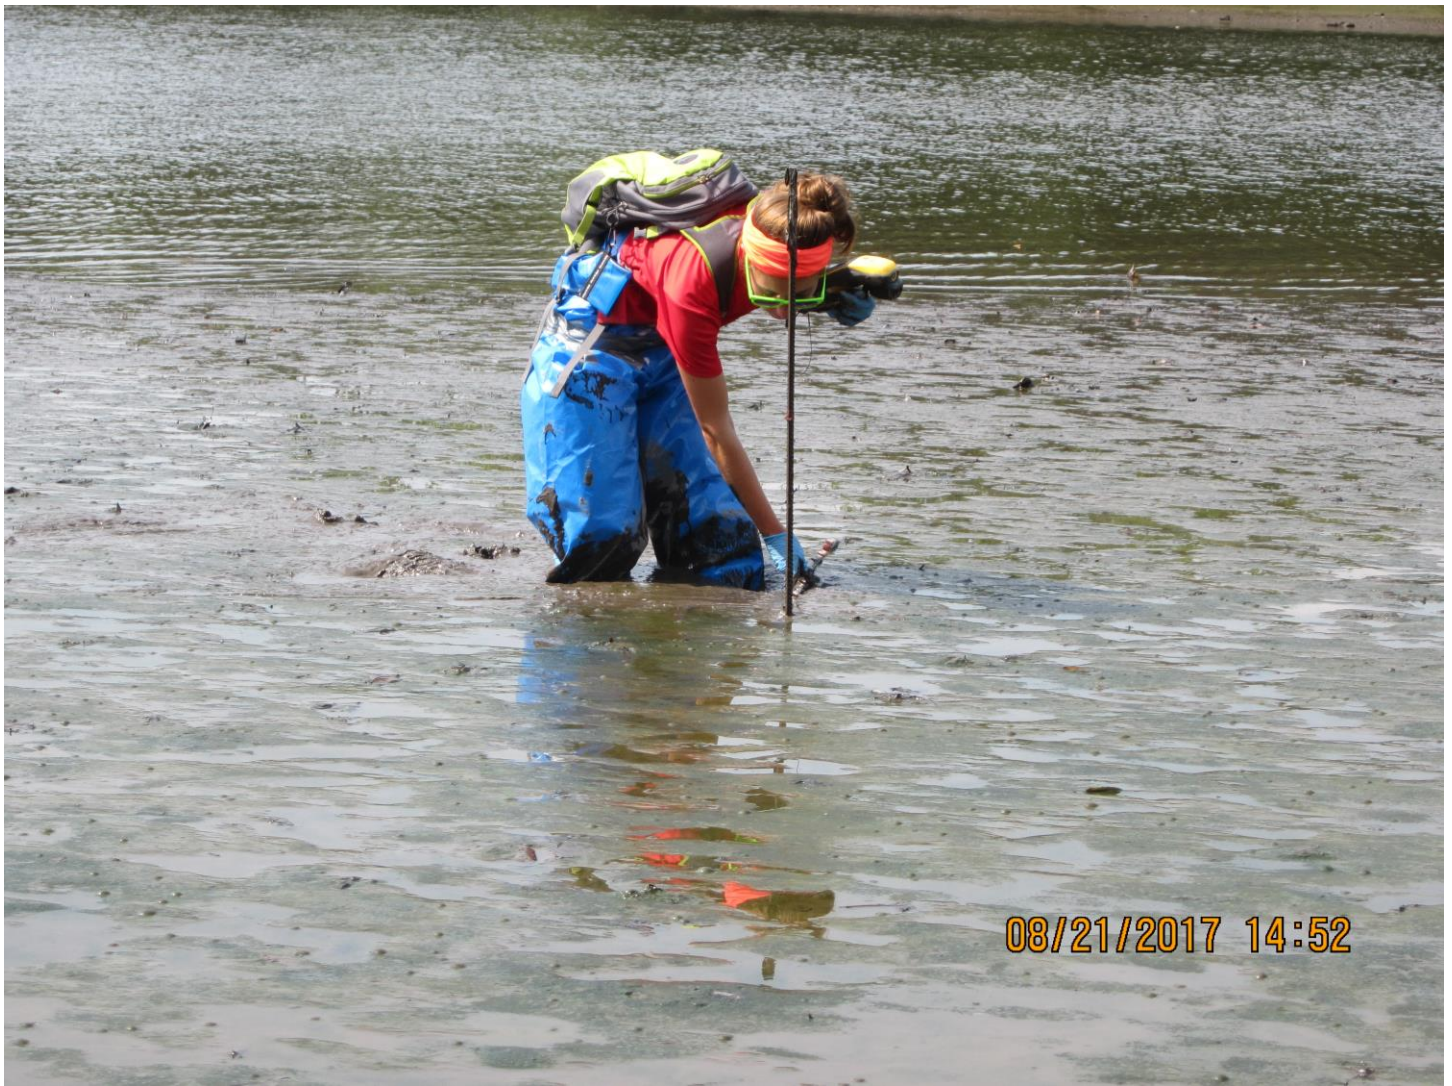
Photograph 3: Measuring grid point distances at AG grid at Transect E (AG-1 through AG-36)

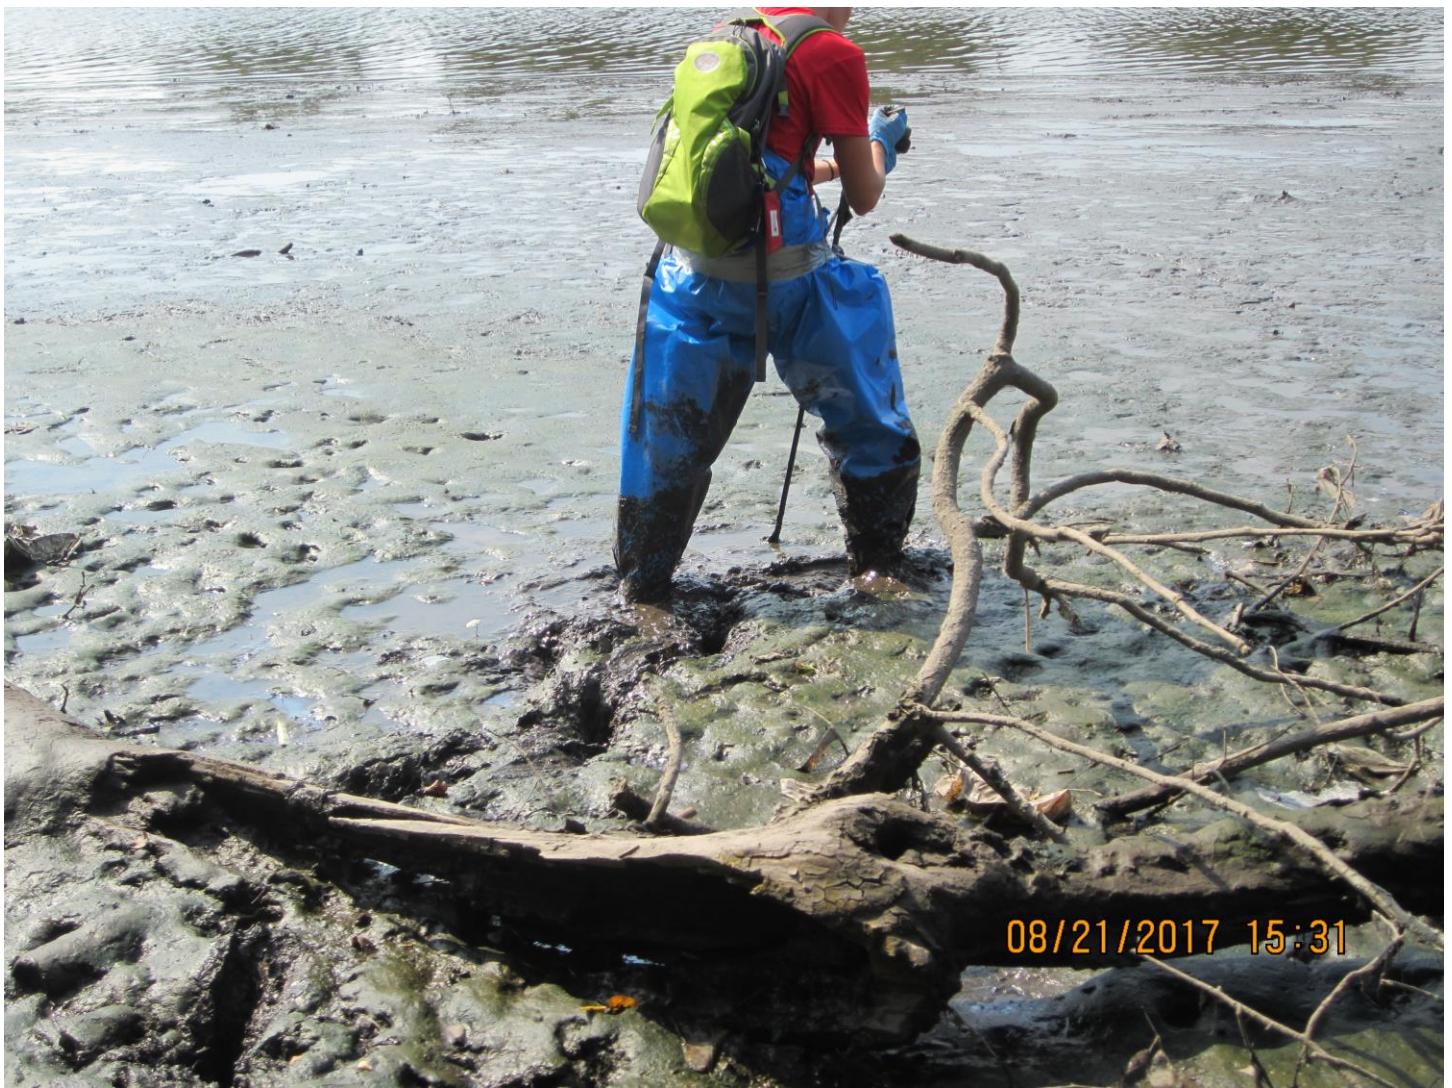
Photograph 4: Probing for southern edge of armor layer at Transect B

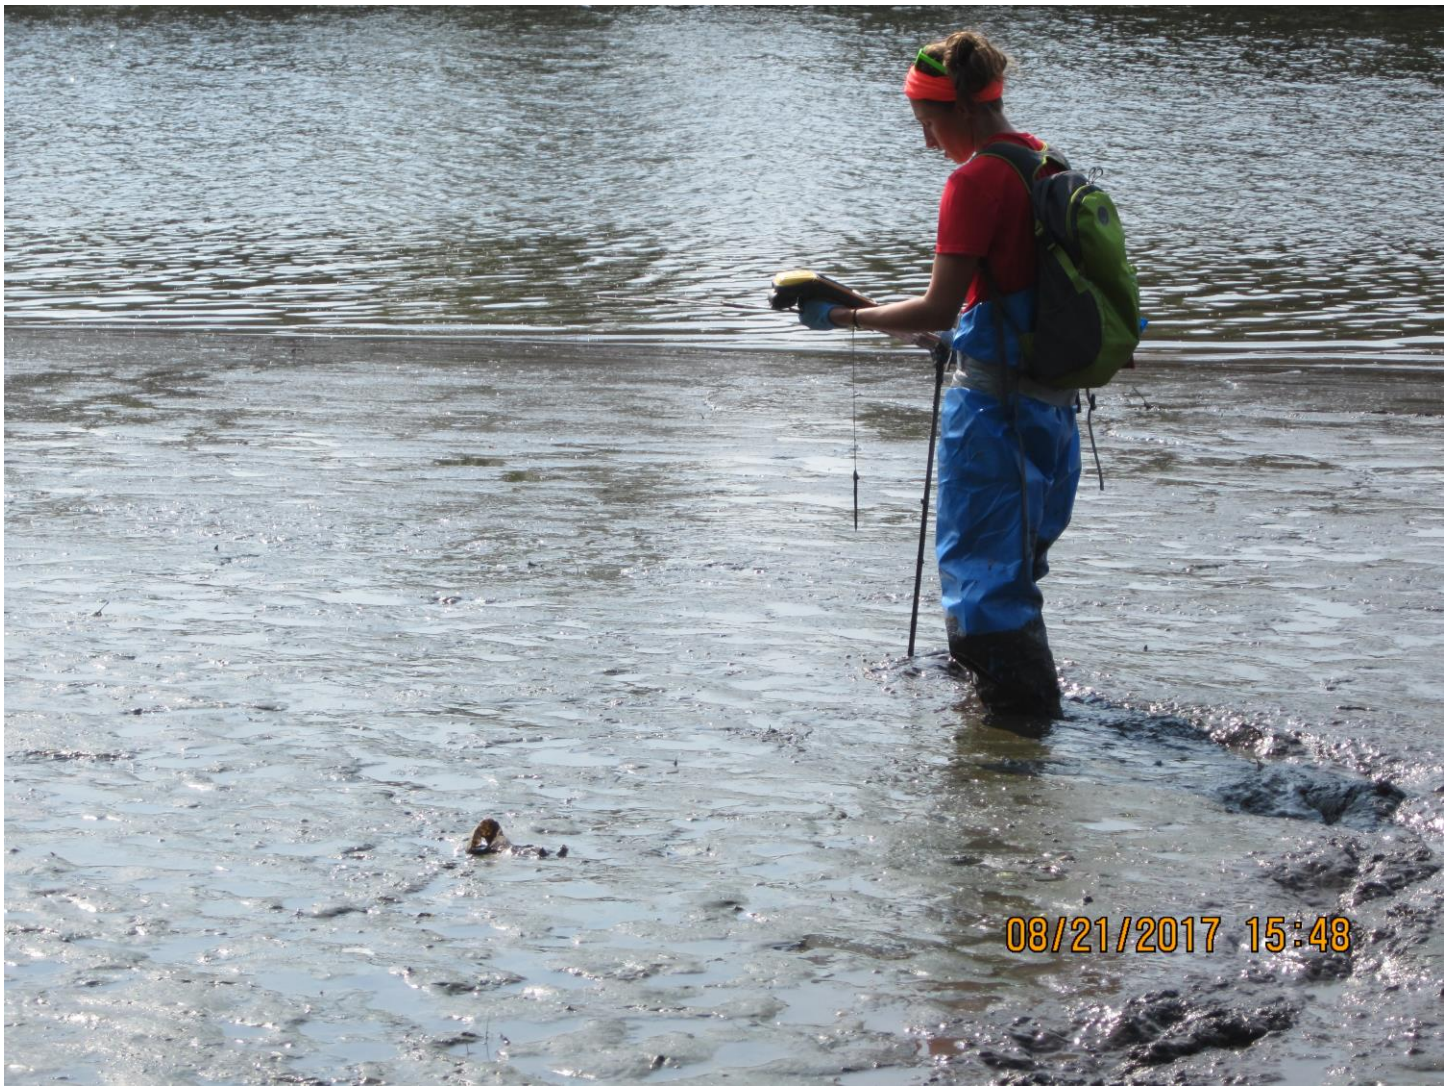
Photograph 5: Recording GPS coordinates at X-3 (Transect X)

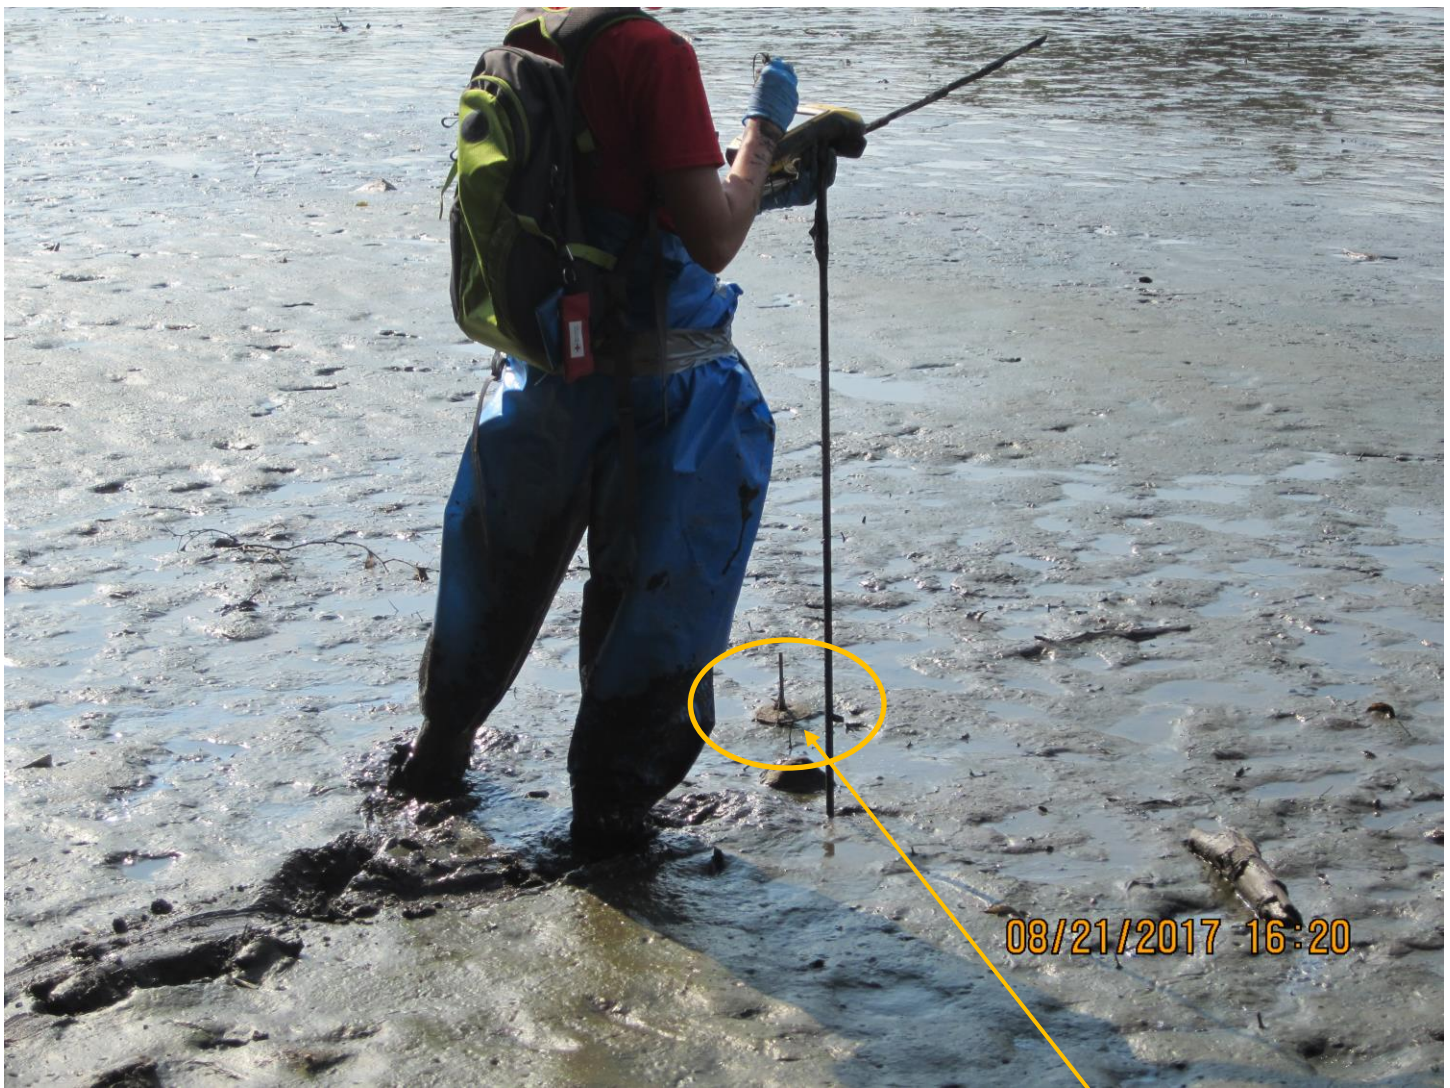
At SPME sampler stations 0606, 0607, and 0608 (along Transects F, G, and H, respectively), the metal rod with steel plate used to identify the sampler station for future sampling events was observed (See Photographs 6 and 7).

Photograph 6: Recording GPS coordinates of Armor-1 in vicinity of G-1 (Transect G). Metal rod and steel plate marking the 0607 sampler station location also visible.

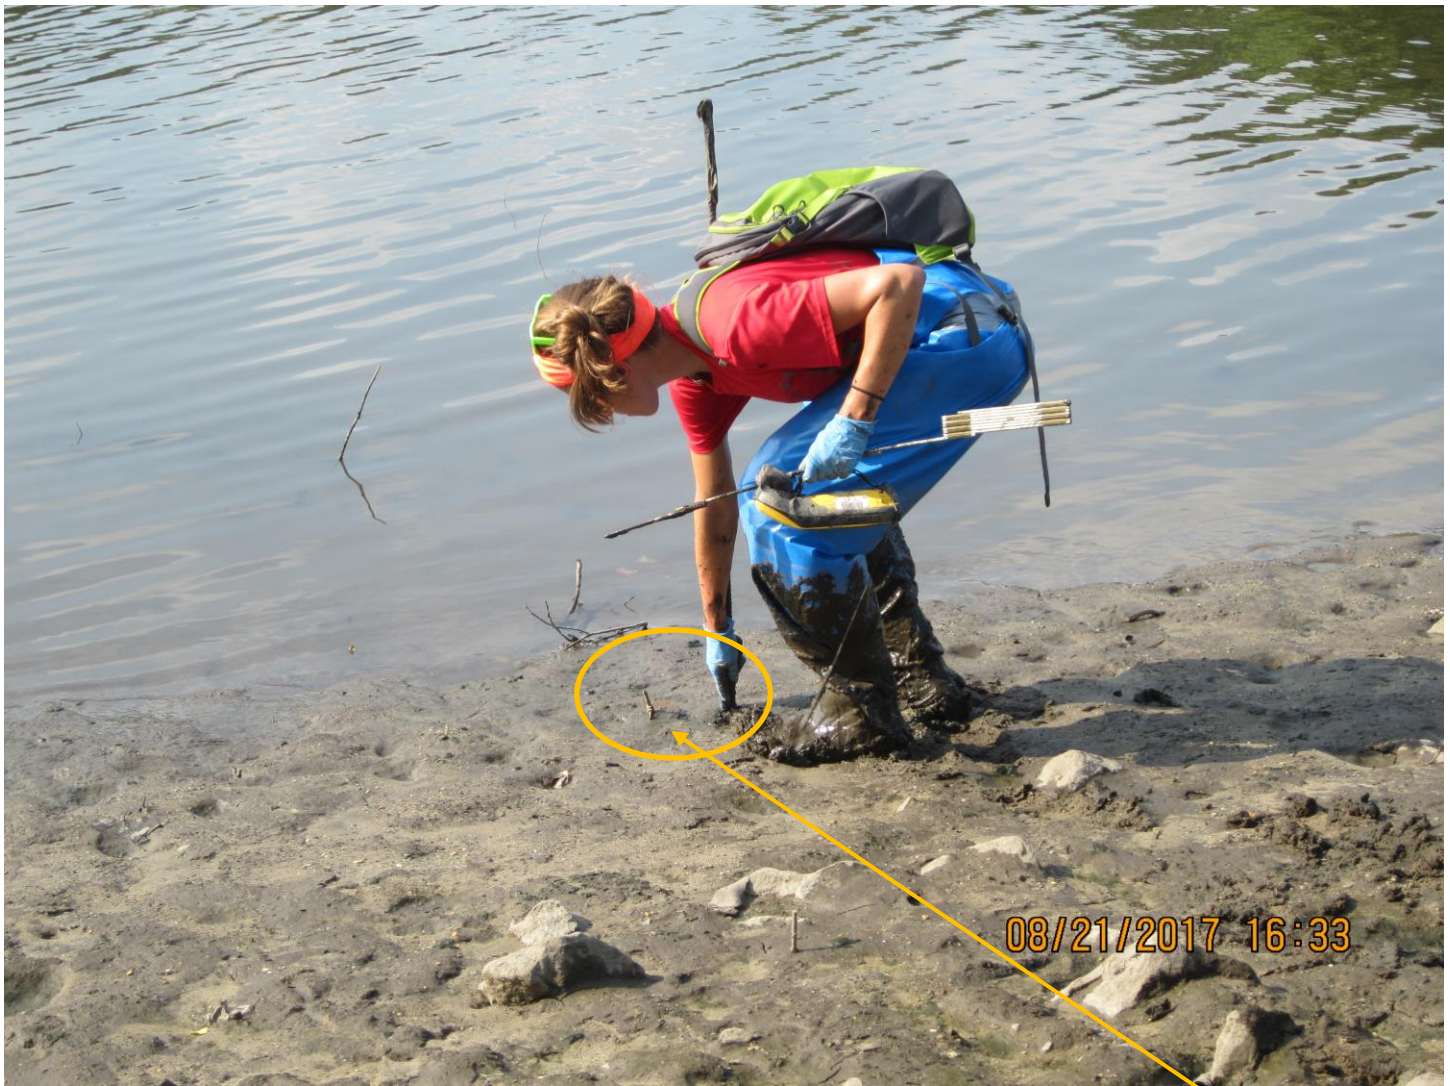
Photograph 7: Measuring depth to armor layer at H-2 (Transect H) near sampling station 0608. Metal rod and steel plate marking the 0608 sampler station location also visible.

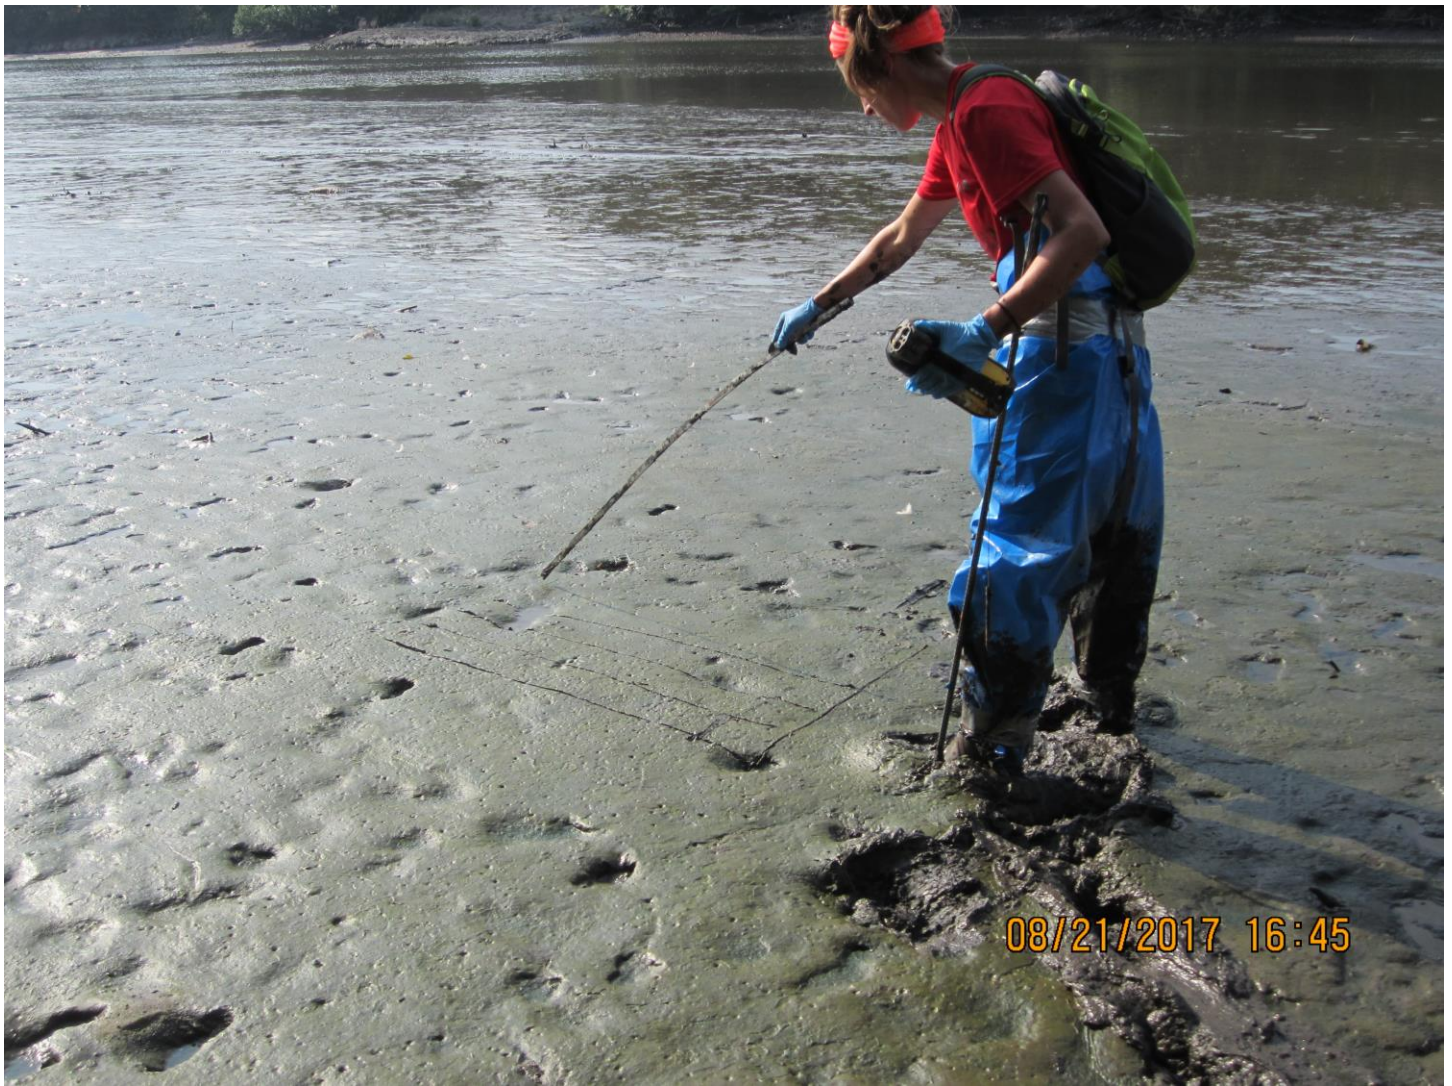
Photograph 8: Drawing out grid BG near 0607 sampling station (Transect G)

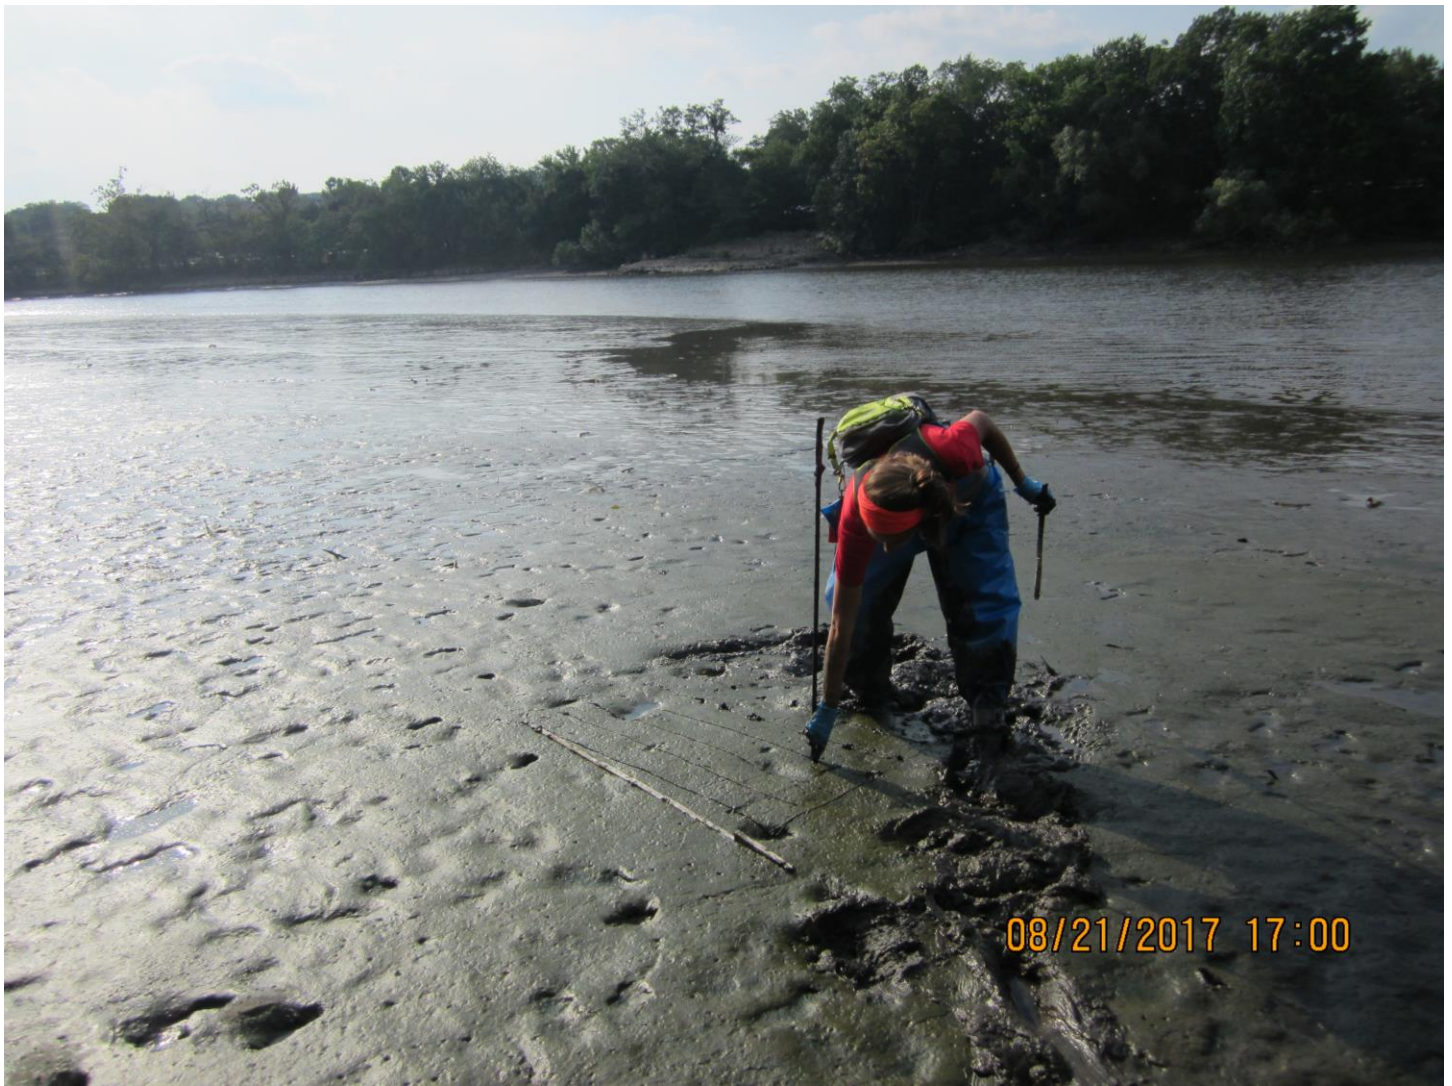
Photograph 9: Measuring depth to armor layer at BG-15 within the BG grid (Transect G)

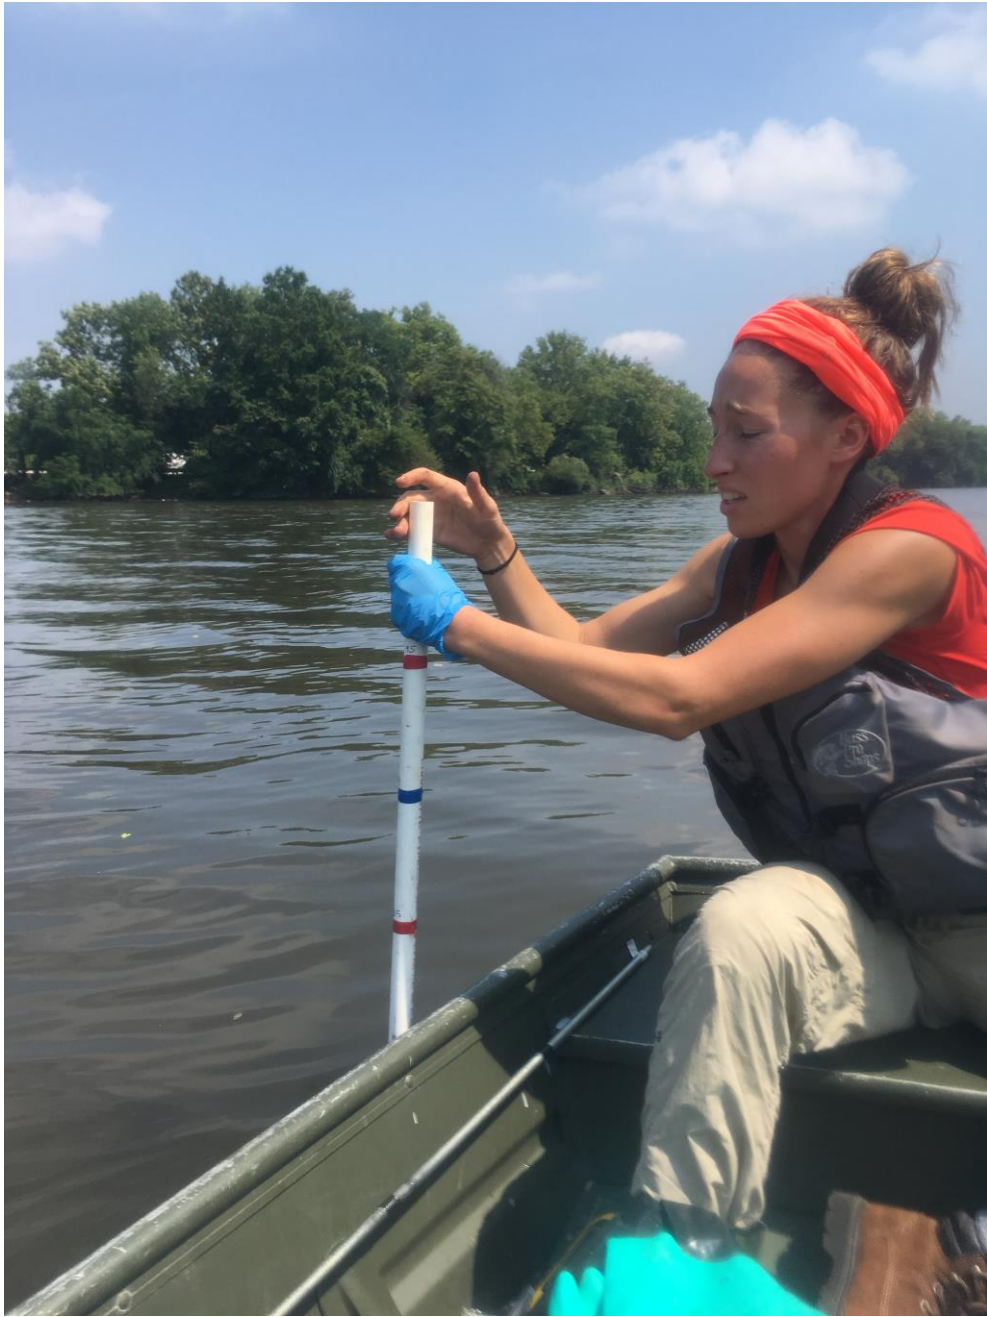
Photograph 10: Initial attempt to measure depth to armor layer with PVC pipe at I-4 (Transect I)

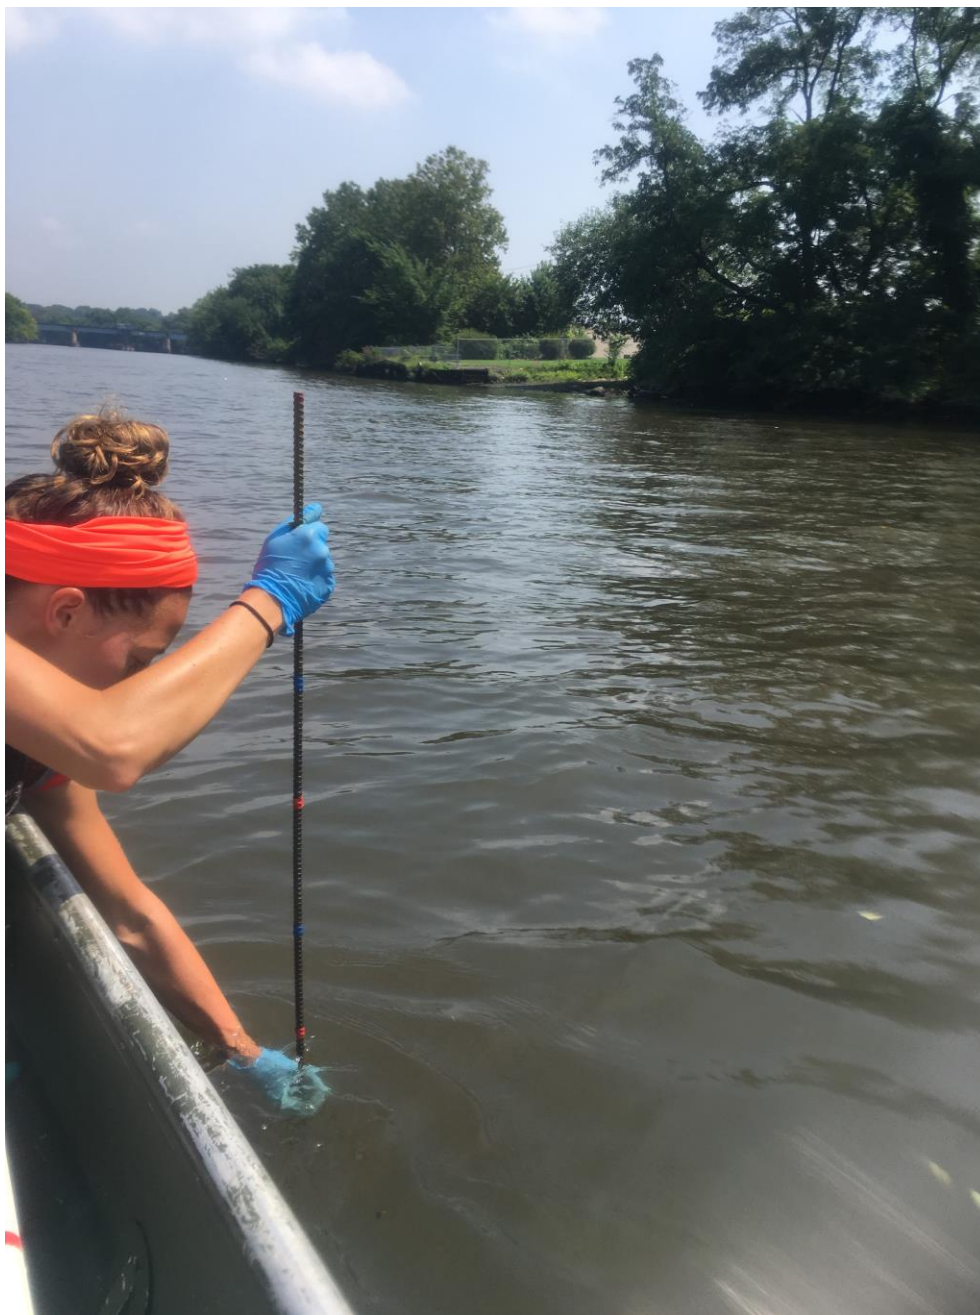
Photograph 11: Measuring depth to armor layer from water surface at G-6 (Transect G)

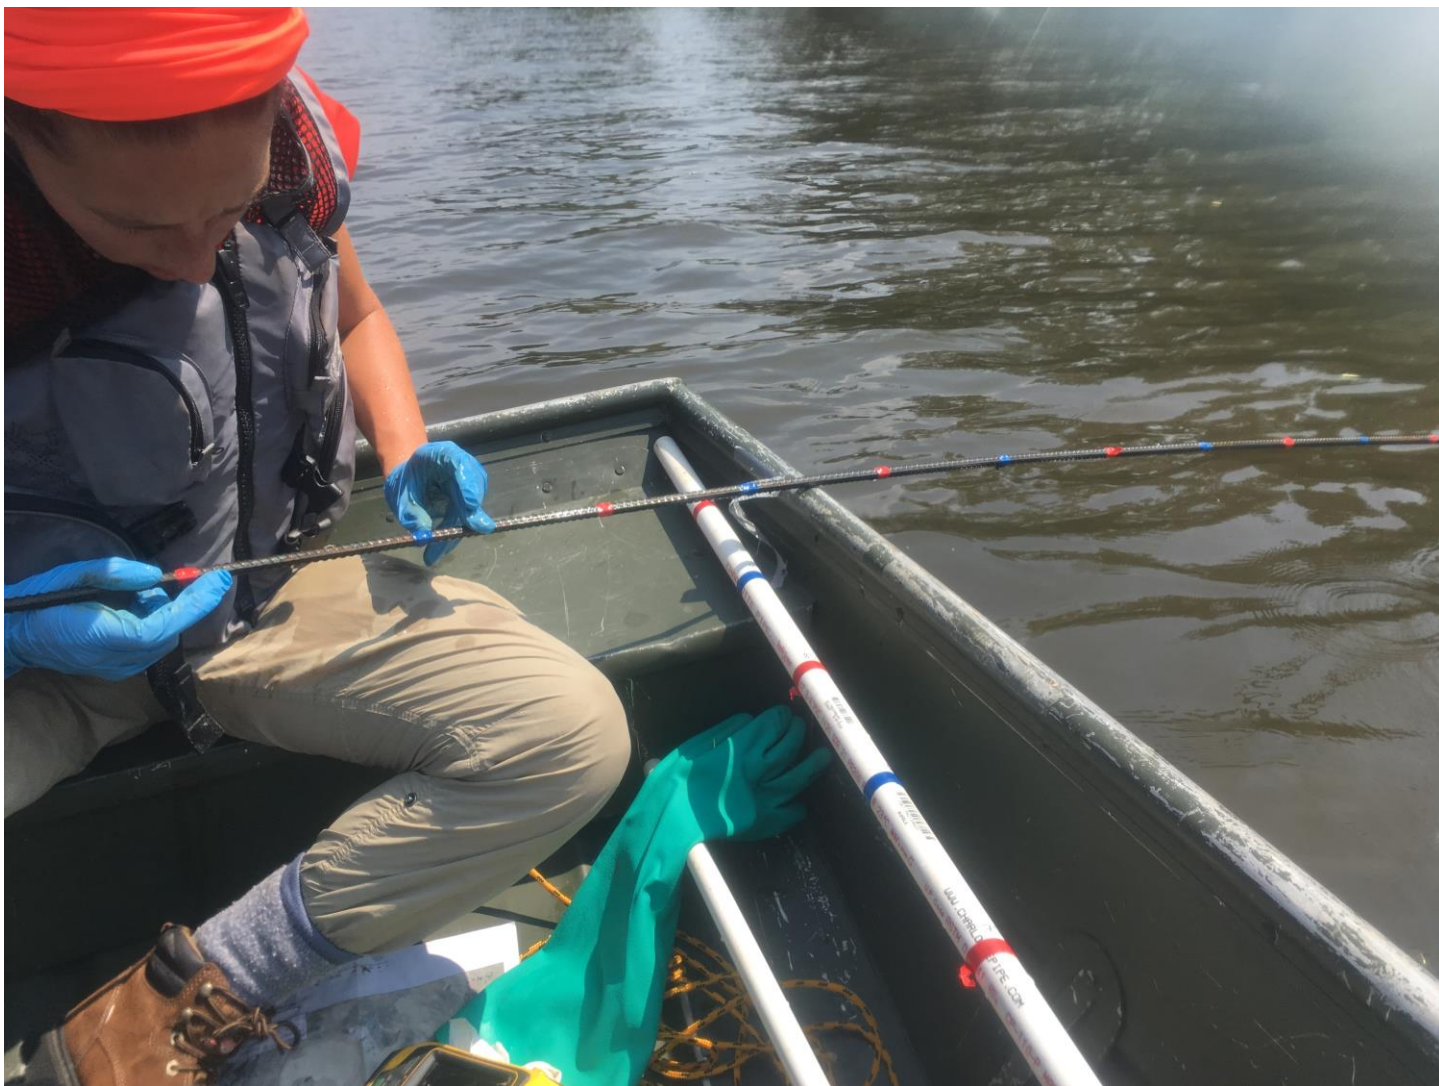
Photograph 12: Counting half foot markers on steel rebar to determine depth to armor layer from water surface at G-6 (Transect G)
